DEPARTMENT OF TRANSPORTATION**DIVISION OF ENGINEERING SERVICES**

Contract #: 04-0120F4Cty: SF/ALA Rte: 80 PM: 13.2/13.9File #: 69.28**WELDING INSPECTION REPORT****Resident Engineer:** Pursell, Gary**Address:** 333 Burma Road**City:** Oakland, CA 94607**Report No:** WIR-014856**Date Inspected:** 23-May-2010**Project Name:** SAS Superstructure**OSM Arrival Time:** 1900**Prime Contractor:** American Bridge/Fluor Enterprises, a JV**OSM Departure Time:** 700**Contractor:** Zhenhua Port Machinery Company, Ltd (ZPMC), Changxing Island **Location:** Shanghai, China**CWI Name:** See Below**CWI Present:** Yes No**Inspected CWI report:** Yes No N/A**Rod Oven in Use:** Yes No N/A**Electrode to specification:** Yes No N/A**Weld Procedures Followed:** Yes No N/A**Qualified Welders:** Yes No N/A**Verified Joint Fit-up:** Yes No N/A**Approved Drawings:** Yes No N/A**Approved WPS:** Yes No N/A**Delayed / Cancelled:** Yes No N/A**Bridge No:** 34-0006**Component:** OBG and Tower**Summary of Items Observed:**

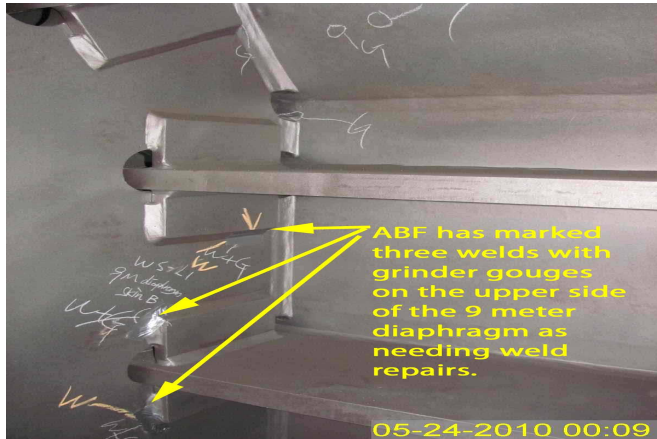
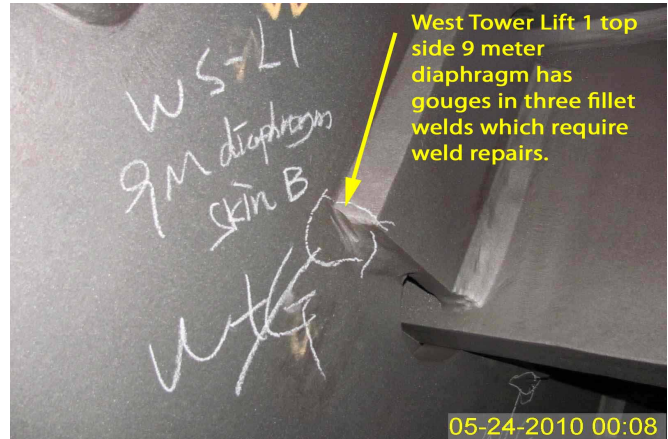
Caltrans QA Inspectors George Goulet, Daniel Barrentine and Paul Dawson performed random visual inspections of these areas. Approximately 8 locations were marked by ZPMC QC, ABF and/or Caltrans Inspectors as needing to be weld repaired. Five of the repair areas were between the 9 and 18 meter diaphragms and three areas were located between the 13 and 18 meter diaphragms. All weld repair areas have been covered by duct tape. Additional photographs of these areas are on the Z drive. Paul Dawson observed the lower side of the 13 meter diaphragm where the back side of one of the stiffener plates appears to have been torch cut and partially welded to fit against the skin plate E. This stiffener plate does not have an identification number, but it is near the center of skin plate E. The area has now been taped over pending repairs. George Goulet noted that skin plate D on the

lower side of the 13 meter diaphragm plate appears to have been gouged between the first and second skin stiffener plates at upper 1200 mm adjacent to the edge of the diaphragm plate. This gouge appears to extend into skin D plate to a depth of approximately 4 MM. This area has now been taped over pending repairs. ABF has marked three fillet welds on the top side of the 9 meter diaphragm as needing to be weld repaired. See the photographs below for additional information. The areas have been taped over pending repairs. Other areas that require rework were marked with colored chalk and ZPMC workers were using electric grinders to remove the visually unacceptable areas and some areas have been identified by Caltrans Inspectors as needing magnetic particle inspections of the arc strike removal areas after they are removed.
